Subject: Facility Assessment of the Town Office Building

Facility Assessment of the

*Southwest Harbor Town Office
Building*

Town of Southwest Harbor, Maine

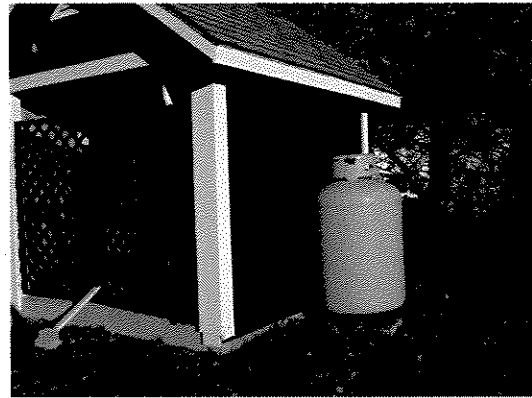
049 Propane Tank

The liquid propane gas tank located adjacent to the emergency generator shed has no collision protection. See Photograph 049. Install two bollards to prevent accidental collision.

Cost \$1,000

Priority 1

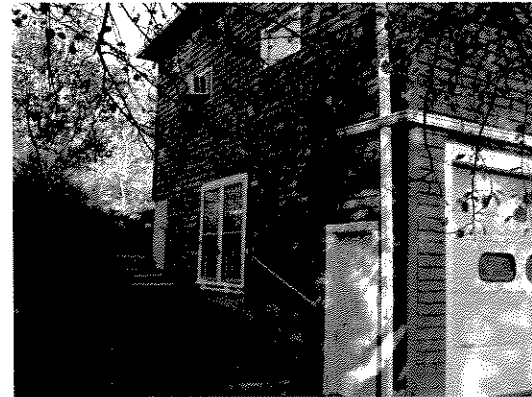
050 Side Exterior Stairs

The Side Exterior Stairs have handrails on only one side and the Front Exterior Stairs do not have handrails at all, both of which do not meet code standards. See Photographs 050, 055, and 059. Install code-compliant handrails at both locations.

Cost \$5,400

Priority 1

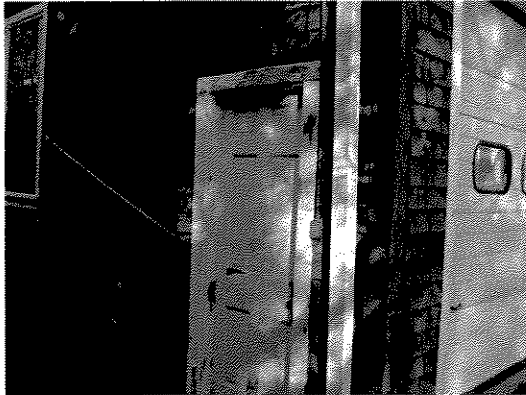
051 Peeling Wood Trim Finish

Exterior walls are wood framed with cedar shingle siding in fair to good condition. There is some damaged paint finish at the lower level side entrance. See Photograph 051. Scrape and repaint trim.

Cost \$500

Priority 3

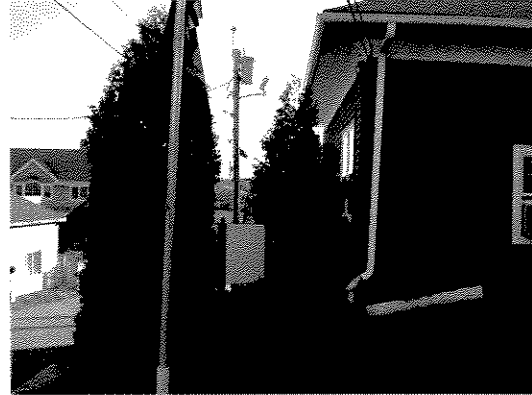
054 Cedar Near Building

Prune and trim as required. There is a cedar that is growing closely to the side of the building. The presence of vegetation close to the building creates an area where moisture may become trapped and roots and water may damage the structure. Relocate the cedar. See Photograph 054.

Cost \$500

Priority 3

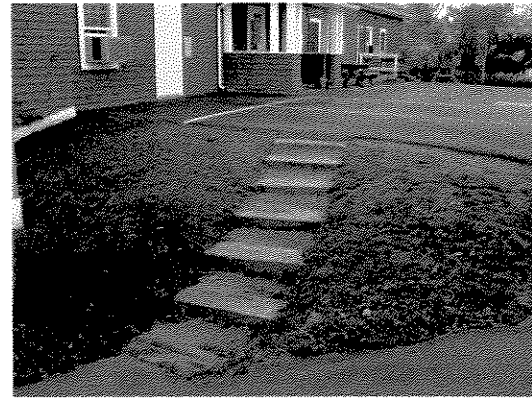
055 Upper Level Front Exterior Stairs

The exterior stairs at the side of the building are uneven and in fair condition. See Picture 055. It is recommended that the exterior stairs be replaced with new.

Cost \$5,000

Priority 4

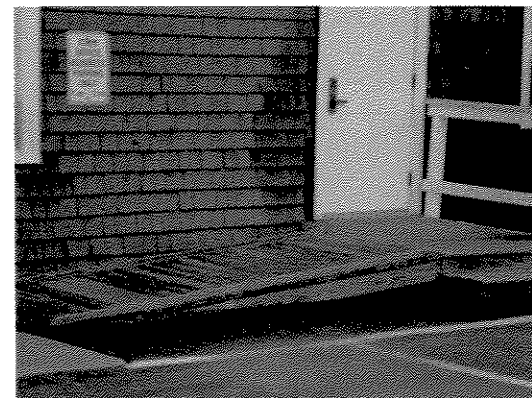
056 Conference Room Exit

The existing ramp does not meet current codes. See Photograph 056. Rebuild the ramp and enlarge the landing, install railings on both sides of new ramp and steps.

Cost \$3,500

Priority 5

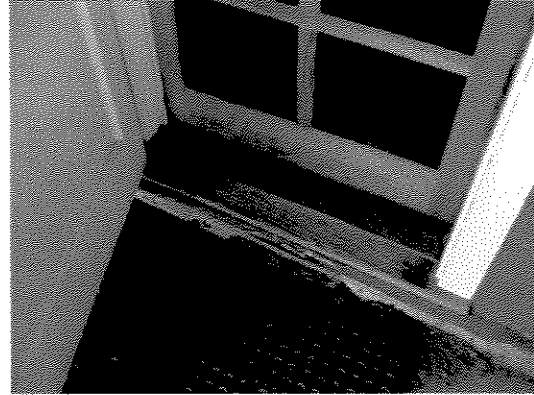
061 Office Entrance Threshold

The threshold is too high for handicap access. See Photograph 061. Lower the threshold to provide adequate access.

Cost \$500

Priority 5

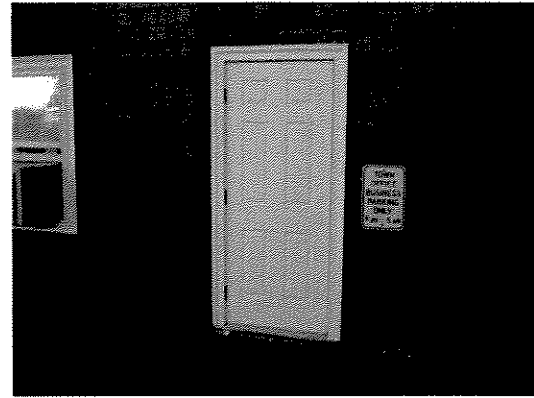
062 Office Area Exit

The Office Area egress is too narrow to meet current code requirements. There is also a screen door that opens in the opposite direction of egress, which does not meet code,

along with a small drop at the doorsill to the exterior. See Photographs 062 and 063. Replace and enlarge the existing egress and install a level insulated exterior landing.

Cost \$5,400

Priority 1

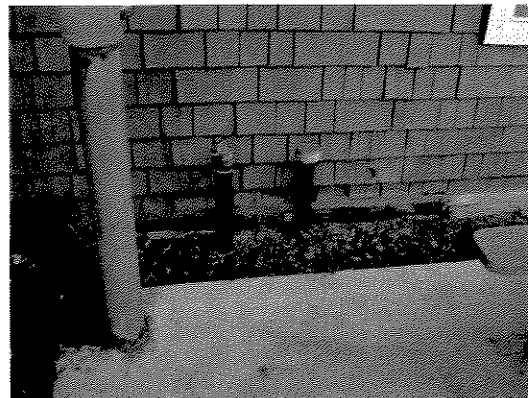
060 Fuel Oil Fill Entrance

Primary fuel storage is a 1000-gallon underground storage tank with a leak detection system. The fuel filling entrance does not have a spill containment sump or an impervious layer beneath it, which could prevent the adequate clean-up of potential spills. See Photograph 060. Install a spill containment sump and concrete apron around the fuel fill entrance.

Cost \$1,500

Priority 1

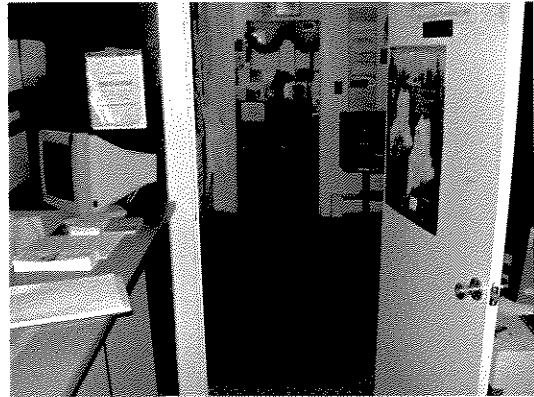
067 Narrow Office Door (Typ)

The interior doors leading to the offices are all too narrow to meet accessibility requirements. See Picture 067. Replace and enlarge the narrow doors and install applicable hardware.

Cost \$16,000

Priority 5

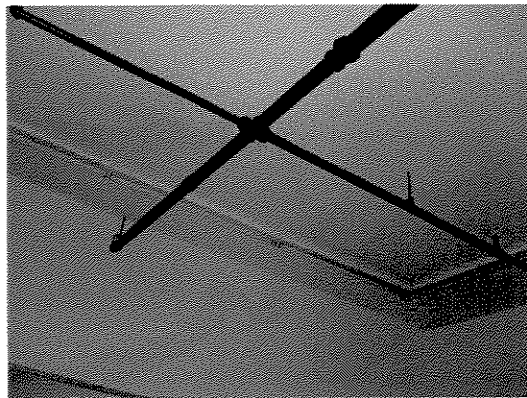
065 Dry Sprinkler System

There is a dry sprinkler system throughout the building that meets current code requirements. See Photographs 065 and 066.

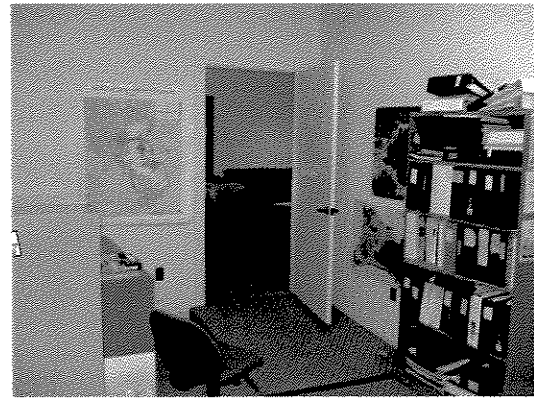
068 Conference Room Entrance

The Conference Room interior access includes a non-compliant carpeted ramp. See Photograph 068. The ramp must be rebuilt to meet code requirements.

Cost \$1,800

Priority 5

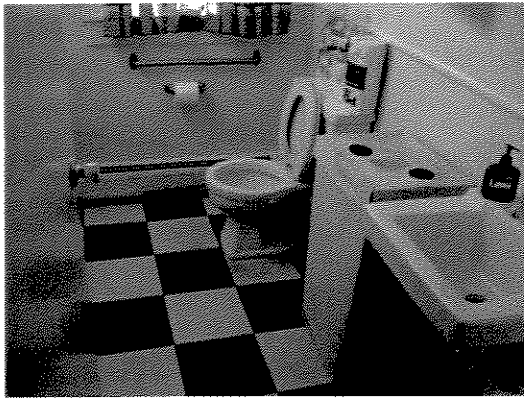
071 Office Restroom (Typ)

The existing men's and women's toilets do not meet handicap requirements. Also, the hallway access to the room is narrow. Combine the two restrooms to form one unisex restroom facility, replace the lavatory and fixtures, replace the toilet, install grab bars, install visual alarm, and replace the door and door hardware. Along with these renovations, enlarge the width of the access hallway. See Photographs 071 and 072.

Cost \$7,500

Priority 5

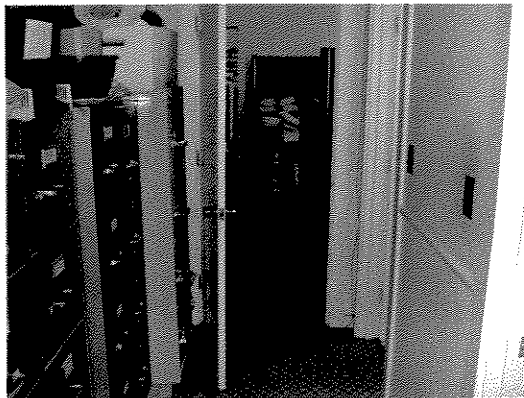
072 Restroom Hallway Access

The interior doors of the two public rooms are too narrow to meet accessibility requirements. See Photograph 072. Replace and enlarge the narrow doors and install applicable hardware.

Cost \$4,000

Priority 1

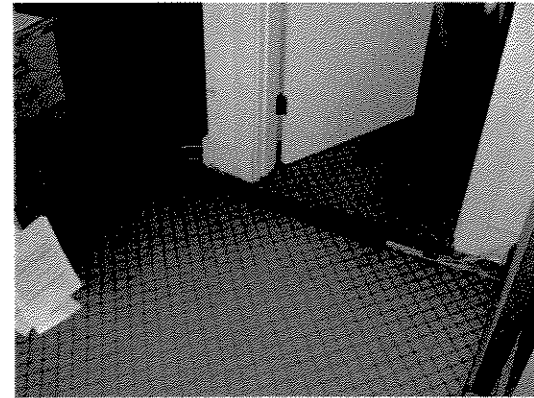
075 Electrical Wiring Along Floor

There are insufficient receptacles throughout the building, resulting in electrical wires being run along the floor to the nearest outlet. See Photograph 075. Install additional receptacles along with related electrical upgrades.

Cost \$12,000

Priority 3

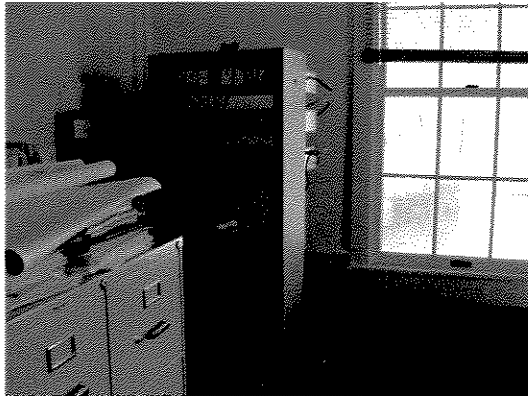
076 Server/Telecom Equipment

The server and telecom equipment is sitting in the corner of an office. See Photograph 076. There is no climate control or security, making it susceptible to damage. Renovate a section of the office to provide an enclosed server room complete with climate control. Coordinate with related ventilation and renovation requirements.

Cost \$6,000

Priority 3

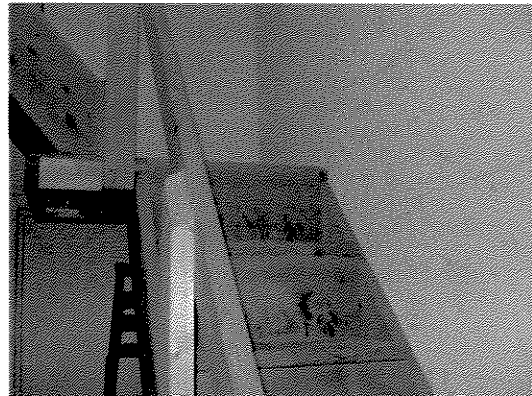
079 Attic Stairs

The stairs to the attic have risers that are too high to meet code requirements for staircases in existing buildings. See Picture 079. Also, the stairs are missing one handrail. Replace the stairs with a code-compliant staircase including handrails on both sides.

Cost \$2,800

Priority 5

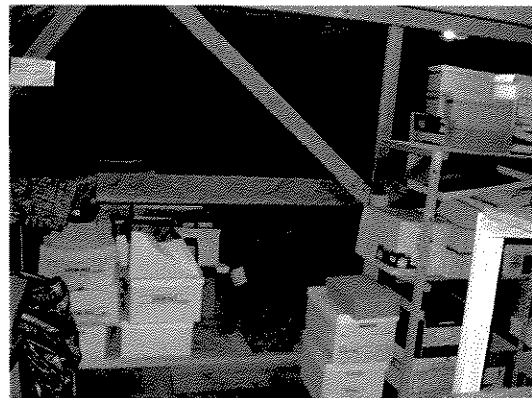
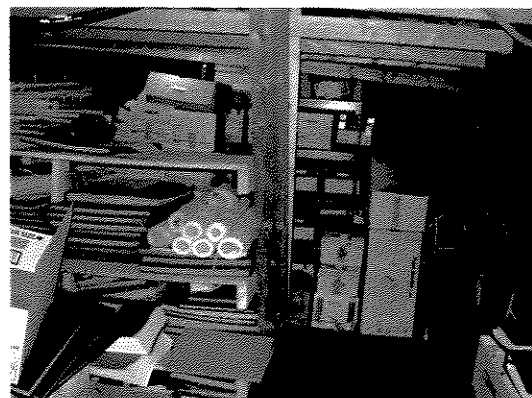
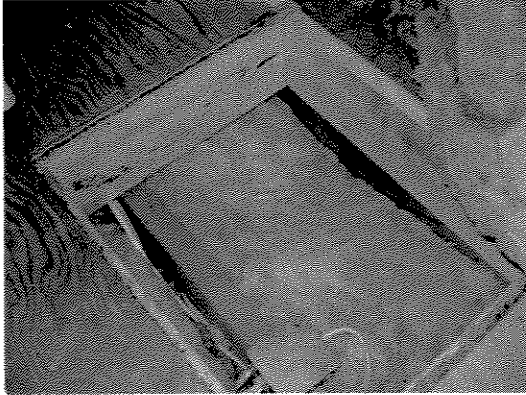
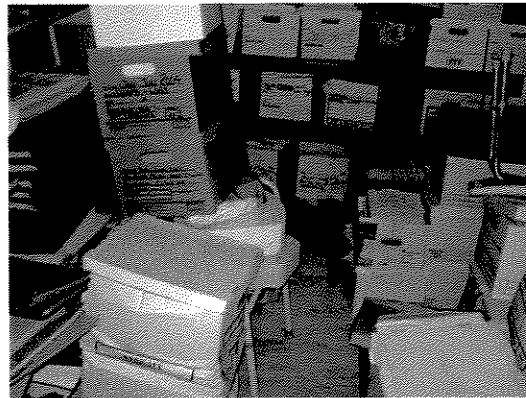
The Attic currently houses paper storage. See Photographs 080 to 084. The floor structure consists of two floors installed at right angles to each other. The second floor structure may have been installed in an attempt to upgrade the floor structurally. Even with this attempt, the floor structure does not have the capacity needed for the type of storage that it is being used for. Additionally, the presence of combustible storage presents a potential fire hazard.

Without the load transfer benefits of the second floor structure, the existing Attic floor structure has a capacity of approximately 20 psf. This is well below what is needed for paper storage.

There are several possibilities to structurally upgrade the Attic floor. The most straightforward upgrade involves removing the existing second floor structure and installing additional structural members to the original floor structure to increase load capacity.

Install 2 x 12 glued-laminated (glulam) joists to the existing floor joists. This will increase the floor capacity to approximately 80 psf. This is the equivalent of approximately 3 filled paper storage boxes stacked on top of each other.

Cost \$26,000

Priority 1

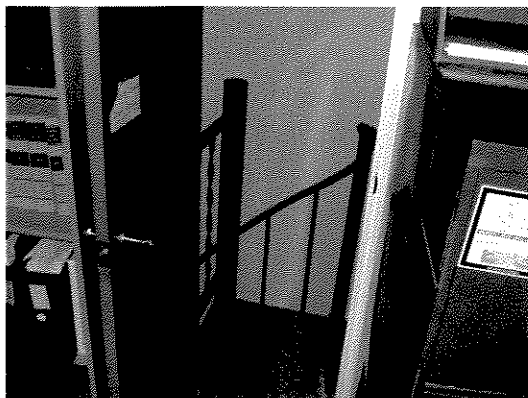
078 Boiler Room Spiral Staircase

There is a narrow spiral staircase leading from the Upper Level to the Boiler Room. This does not meet code requirements regarding vertical fire separation. Remove the staircase and seal the vertical opening with fire-rated construction.

Cost \$2,200

Priority 1

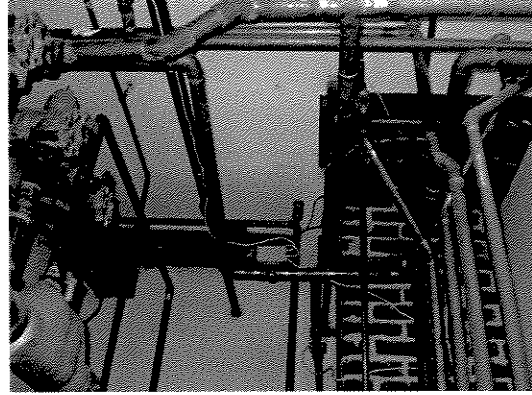
085 Boiler Room Ceiling

The Boiler Room has a non-rated and damaged ceiling. See Photograph 085. Sheath with 5/8" fire rated gypsum wallboard.

Cost \$1,800

Priority 1

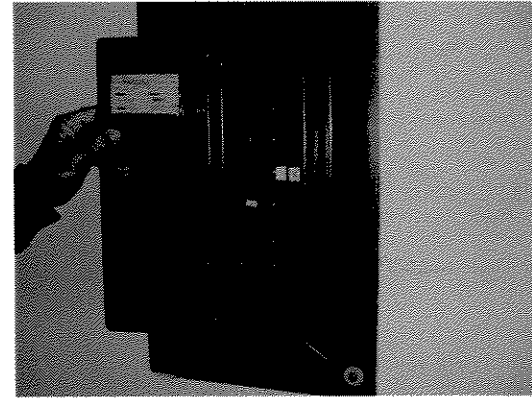
087 Old Pushmatic Panelboard

There is a 200 amp electrical service into the building with an automatic transfer switch to a propane fired emergency generator. The power panel is the original Pushmatic brand. It is difficult to get parts for it and the panel has no expansion capacity. Replace the panel.

Cost \$5,000

Priority 2

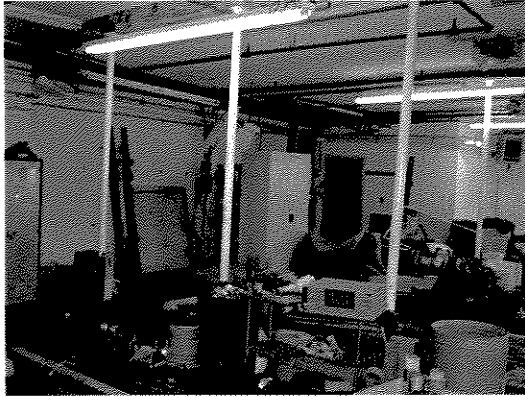
088 Former Fire Station Beams

The area that formerly housed the fire station contains three ceiling beams that are in poor condition. See Photograph 088 and 089. Replace the beams. Coordinate with related Police Station renovation.

Cost \$5,500

Priority 1

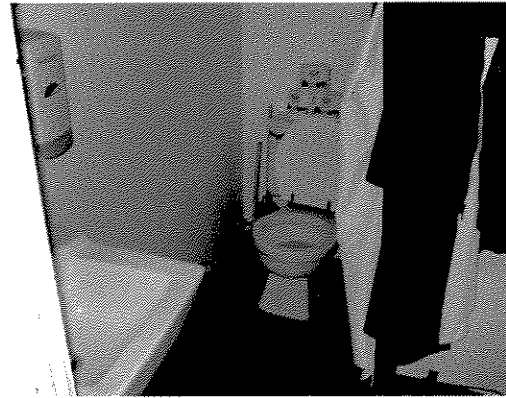
092 Police Station Restroom

The existing toilet does not meet handicap requirements. See Photograph 092. Renovations are included in the Building Envelope section of this report as part of the Lower Level Renovations.

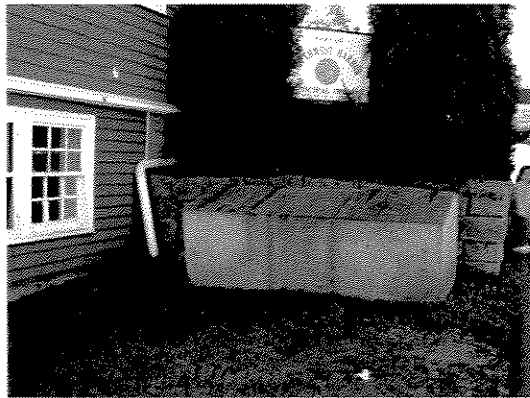
095 Garbage Receptacle

The existing garbage receptacle structure is in poor condition. See Picture 095. Replace and relocate.

Cost \$500

Priority 4
