Subject: Facility Assessment of the Town Office Building

Facility Assessment of the

*Southwest Harbor Town Office
Building*

Town of Southwest Harbor, Maine

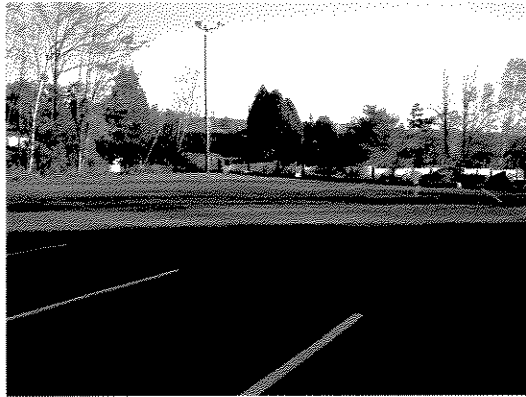
045 Parking Area

There are paved parking areas surrounding the building. Paved areas appear to be in good condition. Periodic sealing and maintenance is recommended.
